Author(s): Nobuo Mimura and Patrick D. Nunn

Source: *Journal of Coastal Research*, Vol. 14, No. 1 (Winter, 1998), pp. 37-46

# Trends of Beach Erosion and Shoreline Protection in Rural Fiji

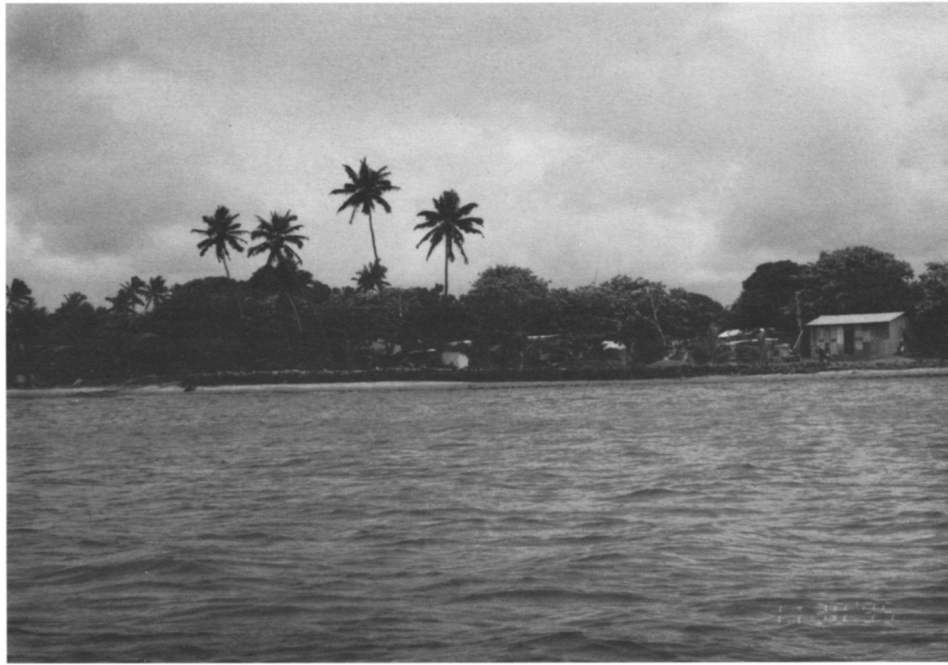
Plate 1. The sea approach to Nukui village.

### Nukui village, Viti Levu (Plate 1 to 3)

Nukui village is located at the mouth of the Rewa Delta on the southeast coast of Viti Levu. It is less than 0.5 m above sea level and the village is only about 250–300 m<sup>2</sup> in size. The population is about 300 and the number of houses about 35. This village has little farming land and is nearly surrounded by the sea and mangrove swamps. Its location is in the direct path of the southeast trade winds and experiences associated rough seas.

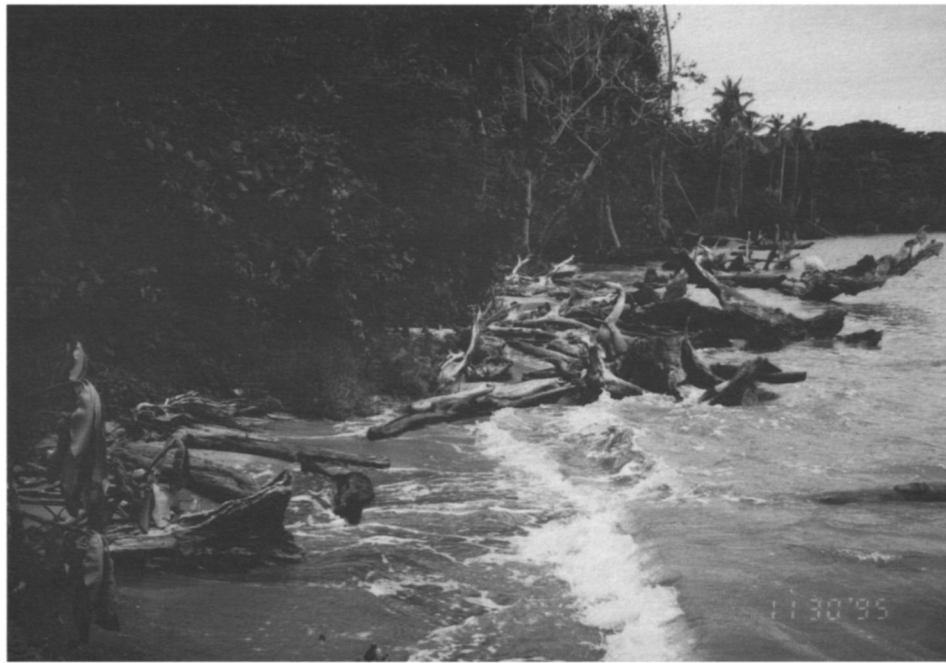
Plate 2. Erosion and trees washed away near Nukui.

Sea encroachment is a very big problem in Nukui. The village headman, Timoci Baserawa (61 years old), who has held this position for 30 years, mentioned that there is no other place to go. The sea is encroaching on nearly all sides of the village. Coastal vegetation like *yevuyevu* (*Hernandia peltata*), *voronibebe* (*Tournefortia argentea*), *dilo* (*Callophyllum inophyllum*) and coconuts have been slowly washed away. Some houses have also had to be relocated.

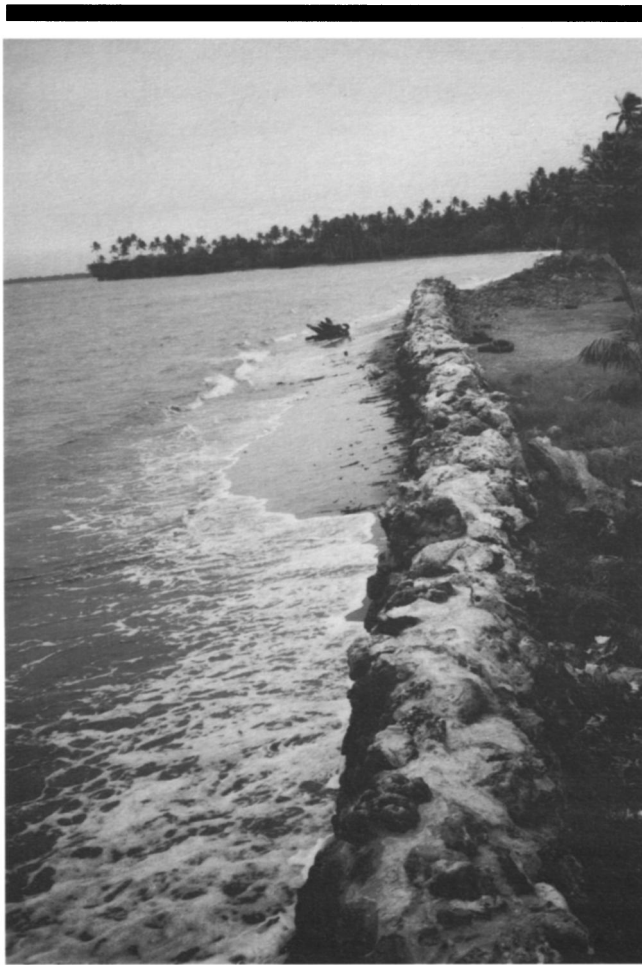
Plate 3. Seawall in front of Nukui village.

Mr Baserawa mentioned that they had been fighting this serious problem for a long time. They had brought in two foreign engineers to help them with the construction of seawalls. The first one came in the early 1960's. He used beach-rock and rocks from the reef. Cement and iron rods were supplied by the government through the *tikina* (district) council; this construction was a vertical one about 1 m high and 50 cm wide. This seawall started to crack and then collapse in the wake of Hurricane Bebe in 1972. Sand now buries much of it.

After the collapse of this seawall in 1972, another engineer came. He also used cement and rocks from the reef but not iron rods. He instructed the villagers to use a different design where the basement was dug down into underlying beach-

rock. The basement is about 1 m wide and narrows towards the top which is about 1.75 meters above the beach now. According to Mr Baserawa, this seawall is much stronger and more effective than the first one. The seawall is constructed about 5 m seaward of the very recent shoreline so that the villagers could reclaim parts of their lost land.

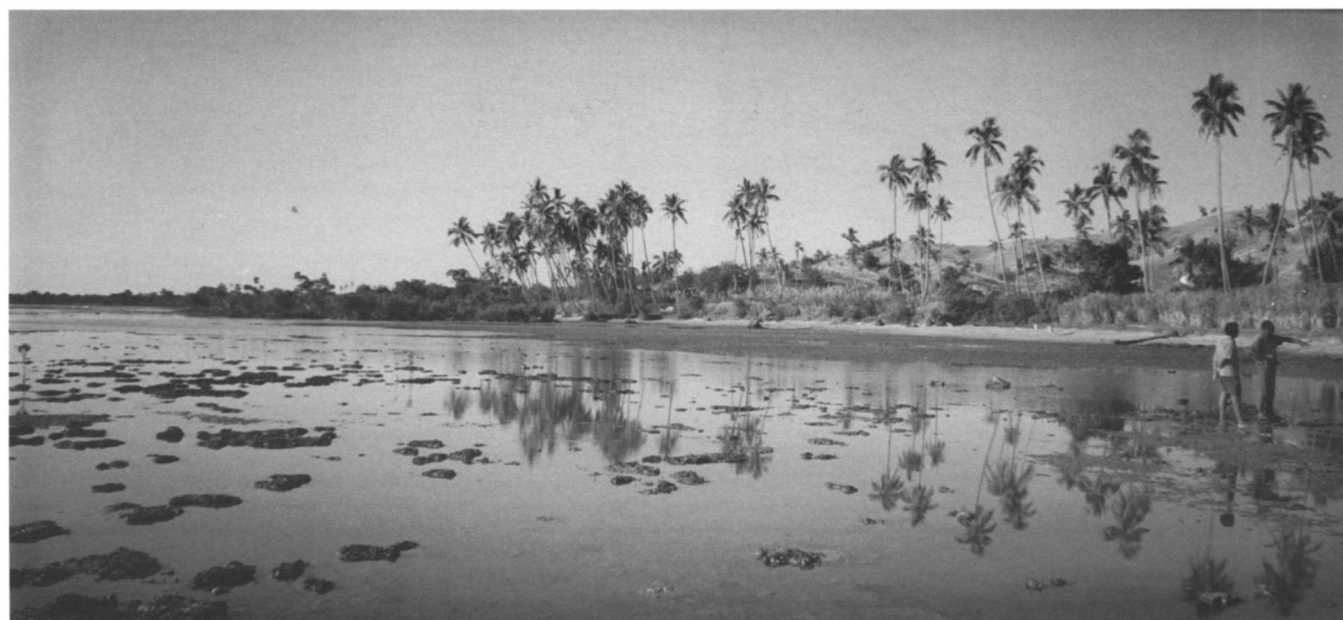
Plate 4. Part of the shoreline at Nabila village which has been cleared of mangroves and other vegetation. The shoreline was once to the left of the photo.

mangrove swamp was cleared on medical advice. This exercise allowed the coast to be eroded quickly (Plate 4). According to Timoci, sea encroachment and coastal erosion became even more of a problem when the land near the shore was cleared for sugar-cane farming. It is evident that the ploughing of the land makes the soil more vulnerable to erosion.

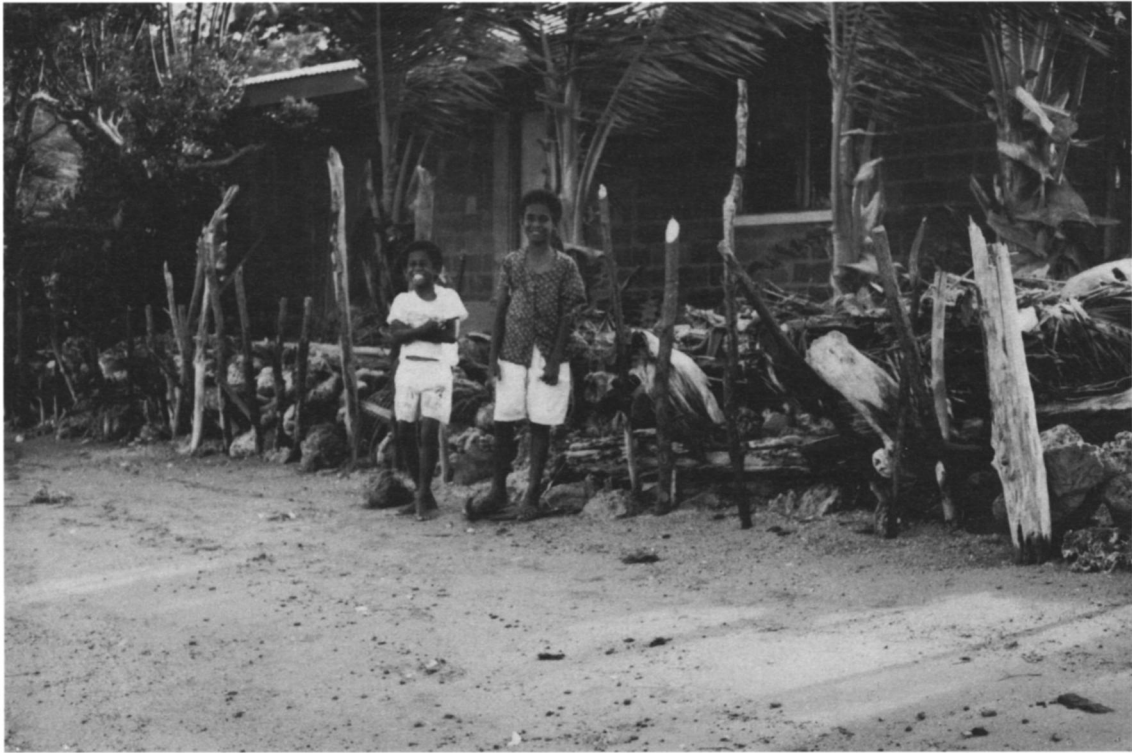
Plate 5. Traditional coastal protection by wooden poles poked into the sand with sand and rubbish piled behind them.

In the distant past, people piled up sediment or stones in unconsolidated piles along the shoreline, or placed sticks along the beach to form a fence behind which debris could be piled. They can be seen even now as shown in Plates 5, 6 and 7. Such structures are likely to be severely eroded during storms, perhaps even under high-tide conditions but, as long as the labour was freely available to rebuild these structures as often as needed, people sought nothing more sophisticated. The change to seawalls and similar structures can thus be seen as a response, not only to the availability of new materials, but also to changing cultural conditions. Labour-intensive solutions of the kind employed in the past would be unlikely to find favour among many rural dwellers today.

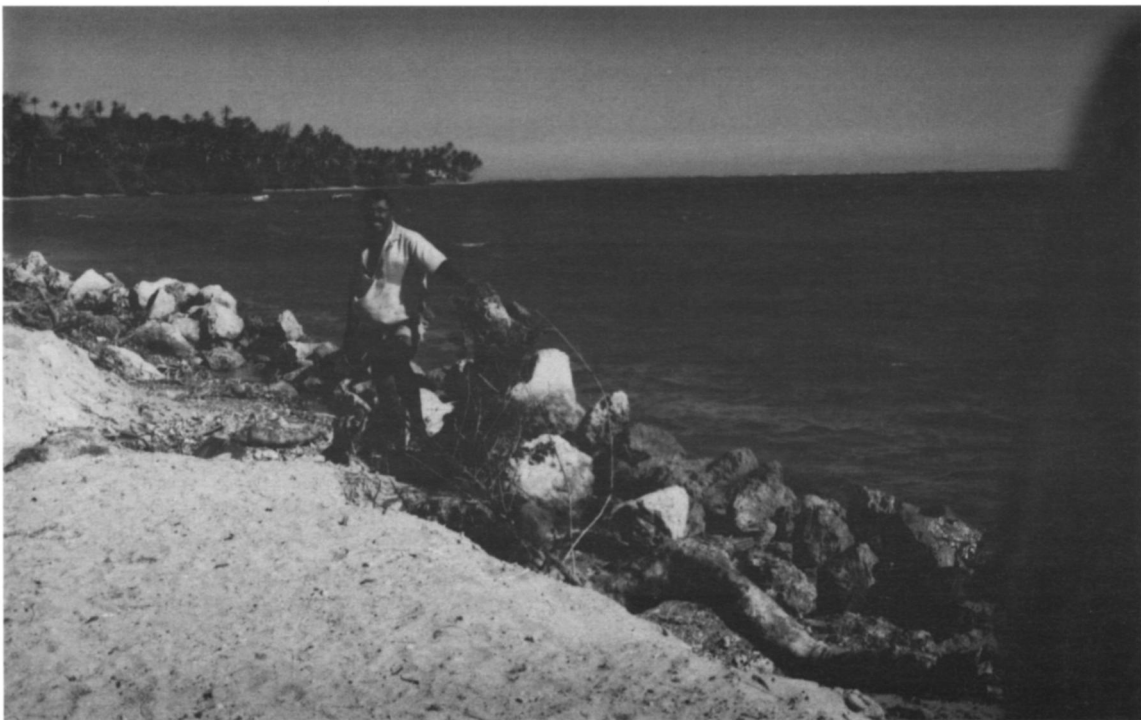
Plate 6. Piled stones along the shoreline.

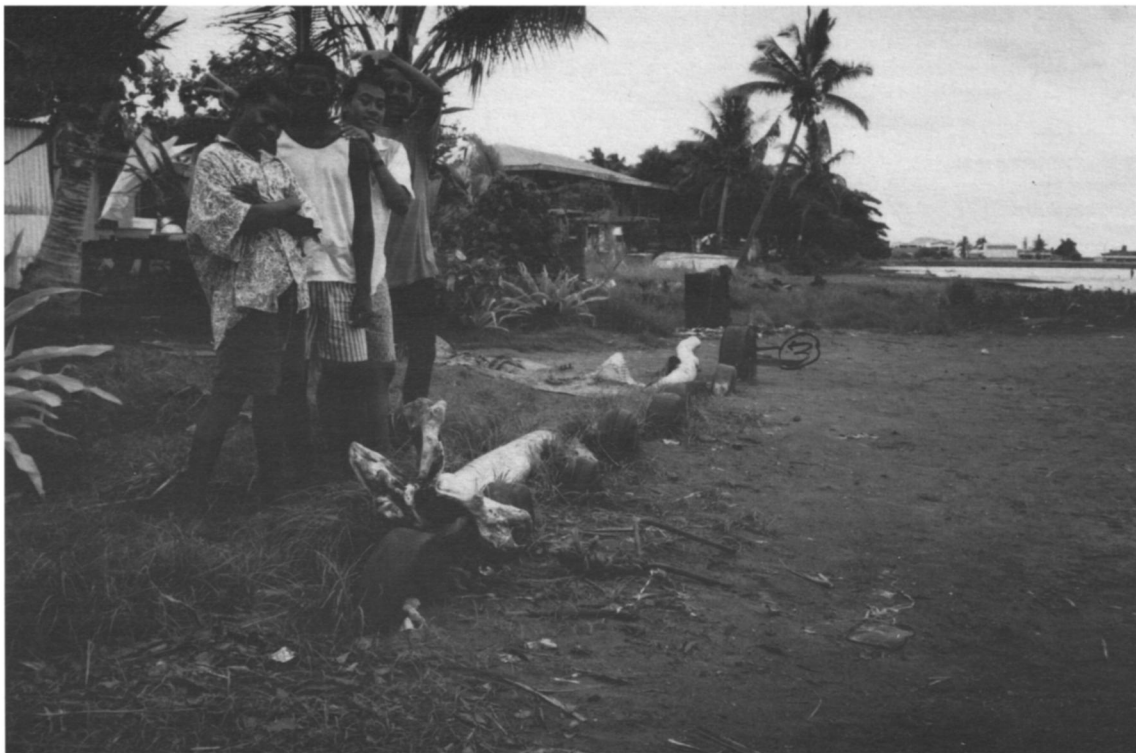
Plate 7. Protection using old tires.

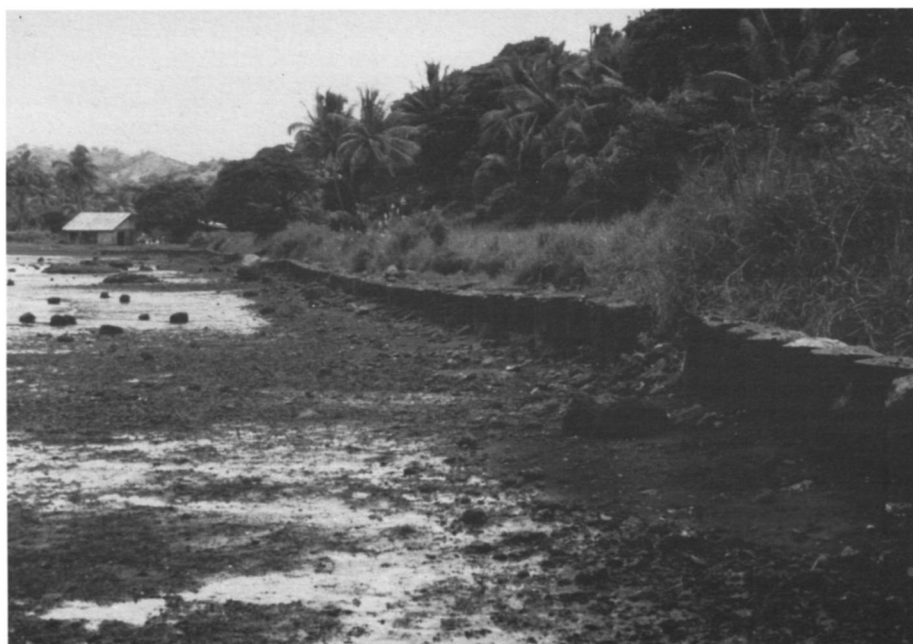
Plate 8. Vertical seawall of drums with concrete inside.

Almost all concrete seawall structures constructed in Fiji are vertical walls; examples are shown in Plates 8, 9 and 10. The prevailing idea is to build a barrier against the sea and wave action along the shoreline to protect the inland. However, vertical hard impermeable structures often generate unfavorable effects, such as strong reflection of waves, scouring of the foot of the seawall, and sucking out of the fill material. These often lead to seawall collapse. Release of sediment from nearshore areas can result in its being relocated on nearby reefs adding to the detrimental ecological impacts of seawall construction.

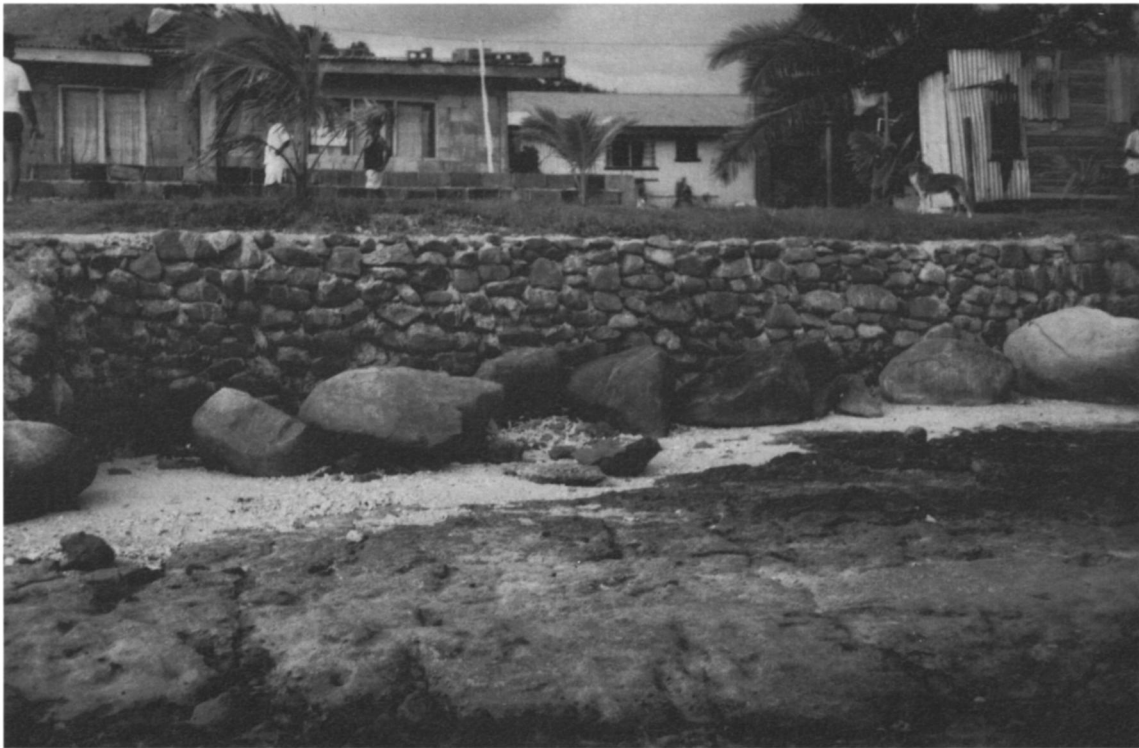
Plate 9. Vertical seawall with toe protection by large stones.
